Smoke and Dye Testing Summary

High Level Sewershed

Run Summary

| Test ID | Test Type | Date Inspected | Company / Super. | Blower MH | Ground Condition | Notification Made? | Total Length |
|---|---|---|---|---|---|---|---|
| S1028-292 | Smoke | 9/10/2009 | ADS/TM | S11001006MH | Dry | Yes | 940.80 |

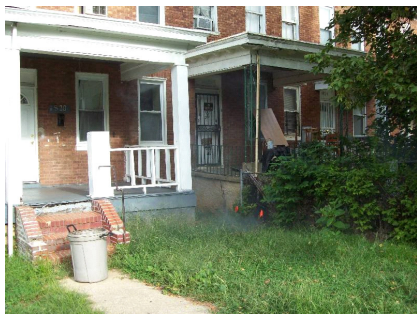
Picture \S1028-292-OB01-P01.jpg

Comments Smoke from service lateral in front yard. 4822 Pimlico Rd.

Comments Front of house, 4822 Pimlico Rd.

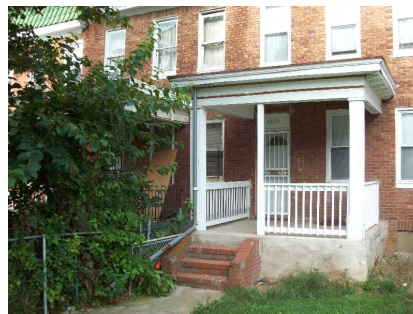
Picture \S1028-292-OB02-P01.jpg

Comments Smoke from service lateral in front yard. 4824 Pimlico Rd.

Comments Front of house, 4824 Pimlico Rd.

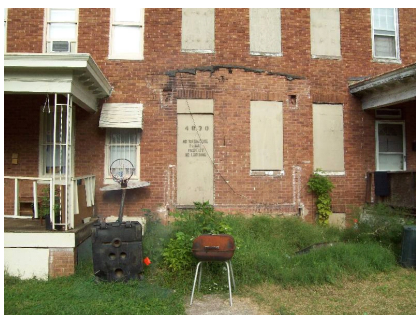
Picture \S1028-292-OB03-P01.jpg

Comments Smoke from cleanout in front yard. 4830 Pimlico Rd.

Comments Front of house, 4830 Pimlico Rd.

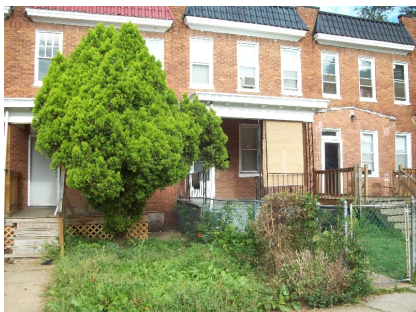
Picture \S1028-292-OB05-P01.jpg

Comments Smoke from service lateral in front yard. 4840 Pimlico Rd.

Comments Front of house, 4840 Pimlico Rd.

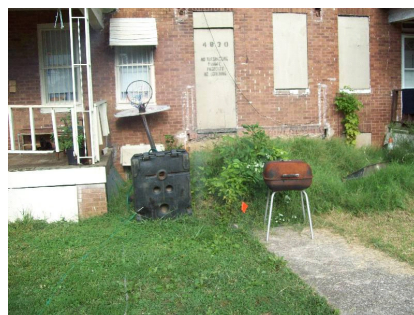
Picture \S1028-292-OB04-P01.jpg

Comments Smoke from service lateral in front yard. 4830 Pimlico Rd.

Comments Front of house, 4830 Pimlico Rd.

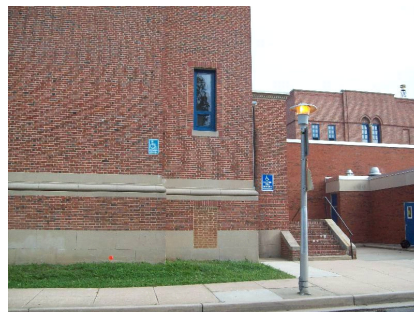
Picture \S1028-292-OB06-P01.jpg

Comments Smoke from service lateral in side yard. 4849 Pimlico Rd.

Comments Side of building, 4849 Pimlico Rd.

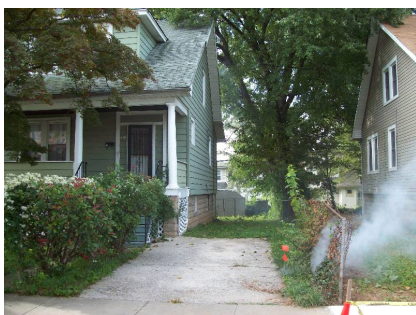
Picture \S1028-292-OB07-P01.jpg

Comments Smoke from service lateral in front yard. 2921 Thorndale Ave.

Comments Front of house, 2921 Thorndale Ave.

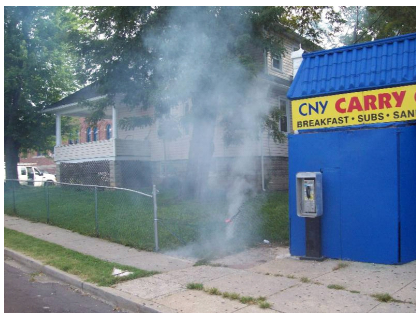
Picture \S1028-292-OB09-P01.jpg

Comments Smoke from cleanout in side yard. 2925 Thorndale Ave.

Comments Side of house, 2925 Thorndale Ave.

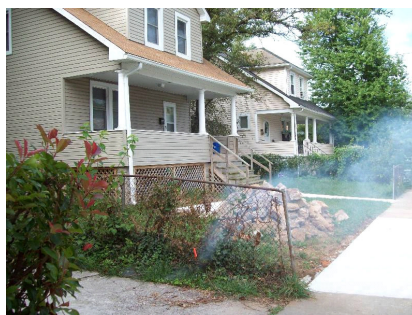
Picture \S1028-292-OB08-P01.jpg

Comments Smoke from cleanout in front yard. 2921 Thorndale Ave.

Comments Front of house, 2921 Thorndale Ave.

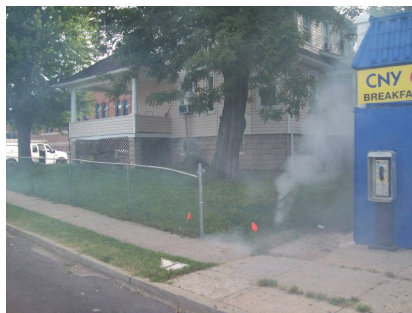
Picture \S1028-292-OB10-P01.jpg

Comments Smoke from service lateral in side yard. 2925 Thorndale Ave.

Comments Side of house, 2925 Thorndale Ave.

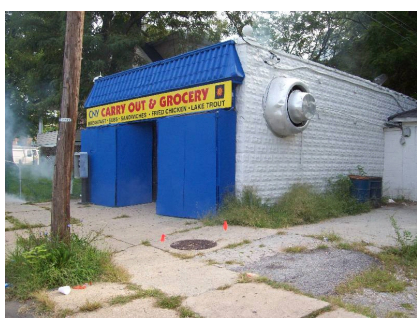
Picture \S1028-292-OB11-P01.jpg

Comments Smoke from utility manhole in sidewalk. 4817 Pimlico Rd.

Comments Front of building, 4817 Pimlico Rd.
